SmartSolar MPPT 250/100-Tr VE.Can issue with capacitor C609

Technote July 2022

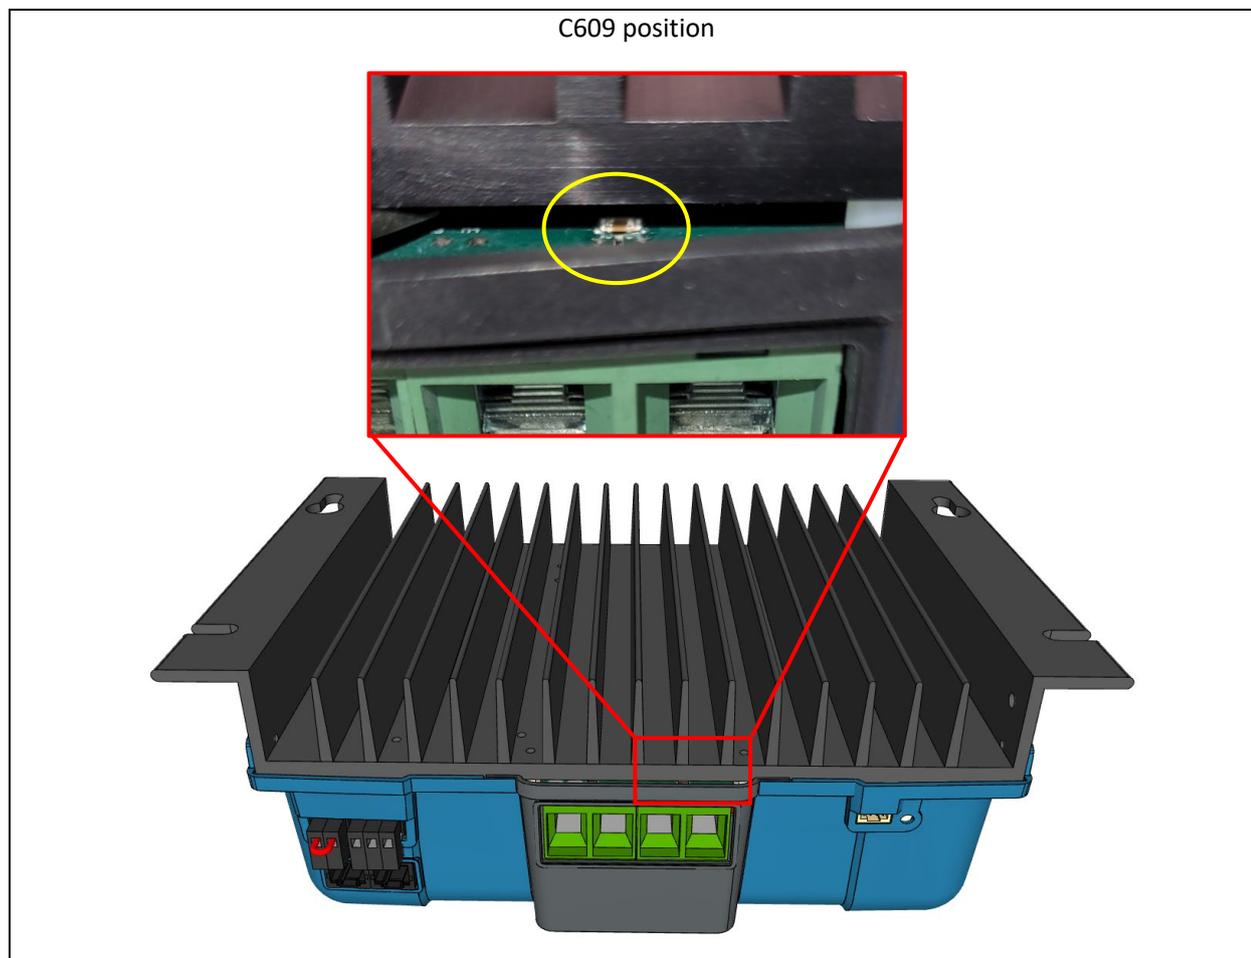
Make sure to disconnect PV and Battery

C609 is not necessary for the unit to function properly. Removing it will eliminate the unit to be at risk. C609 is accessible through the gap between the plastic insert and heatsink. C609 can be removed mechanically by using a simple bent metal strip (S-tool), tapping the tool with a hammer breaks the capacitor off the PCB.
